Service Letter

58-G-18

1958 Thunderbird miscellaneous items

REAR SUSPENSION NOISE

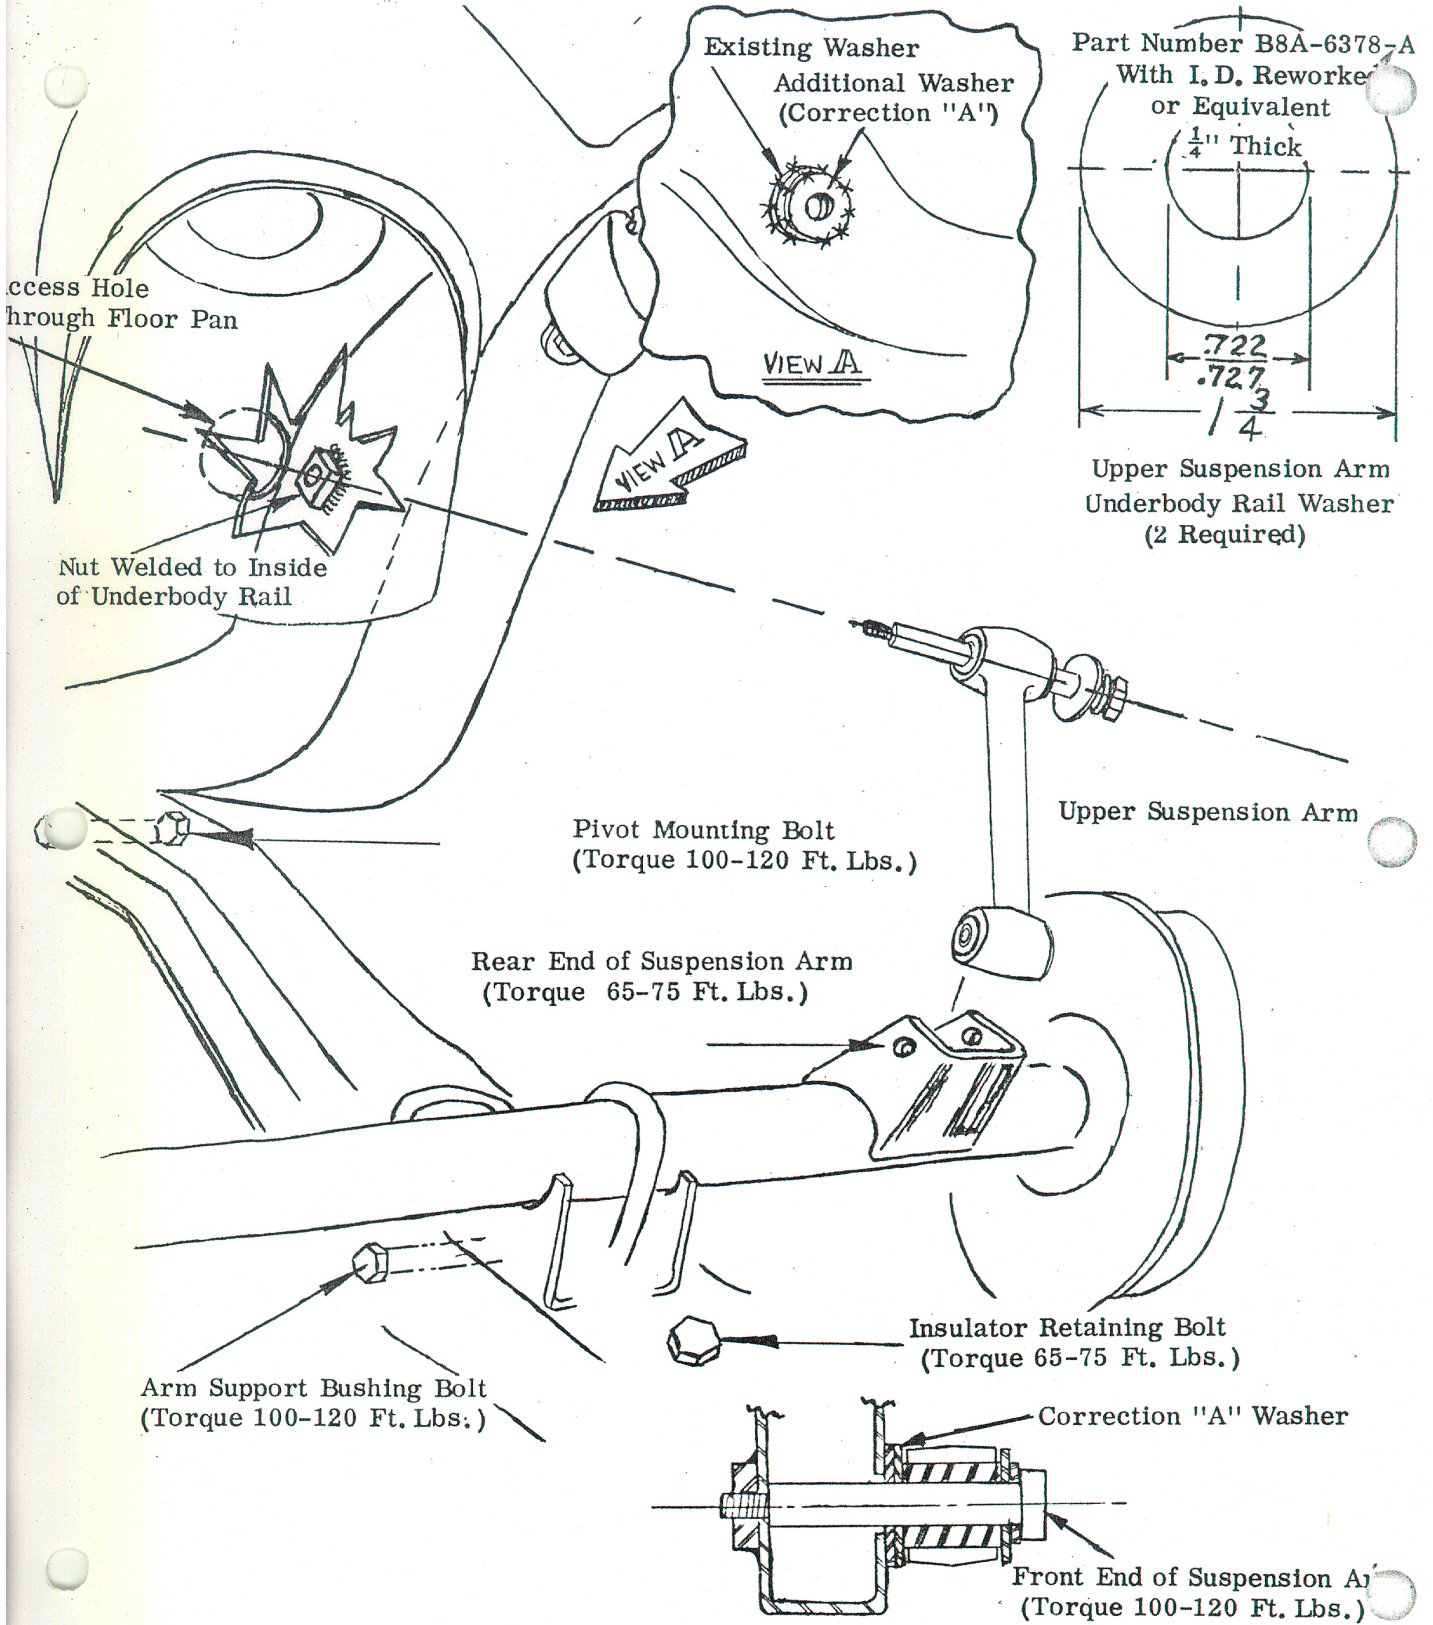
Fig. 1 - Rear Suspension - Noise Correction

An investigation into the causes of rear suspension noise has determined that most noise conditions are caused by the following:

1. Incorrect torque of the rear suspension bolts and nuts.
2. Upper suspension arm looseness. (Upper suspension arm looseness has been found to be caused by one or more of the following conditions):
 - A. Excessive clearance between front bolt and underbody outside rail.
 - B. Stripped threads—upper suspension arm front mounting nut.
 - C. Nut loose on underbody rail.

CORRECTION (A) EXCESSIVE CLEARANCE BETWEEN FRONT UPPER SUSPENSION ARM MOUNTING BOLT AND OUTSIDE UNDERBODY RAIL.

When rear suspension noise problems are encountered, the rear suspension members should be torqued to the revised torque specifications as shown in Figure 1. In those cases where this retorquing operation does not eliminate the noise, and the noise is attributed to the upper suspension arm, the arm and attaching parts should be reworked as follows for the conditions which are found to exist.

3. Wire-brush underbody members in area of front mounting bracket to provide clean surface for new washers to be welded over existing washers.

NOTE: APPLY WET ASBESTOS PACKING TO FUEL LINE AND ADJACENT AREA ON LEFT HAND UNDERBODY RAIL.

4. Position reworked flat washers—B8A-6378-A over existing washers. See Figure 1. Insert bolts through washers into nuts to align washers for welding. Weld washers to underbody rails and remove bolts.
5. Remove wet asbestos packing from left underbody rail and clean welded areas as required.
6. Install the arm and bushing assemblies (front bushing first) to underbody rail, then substitute (2) 34853-S7 split type lock washers for the star type washers removed.
7. Connect arms to axle brackets, secure with bolts, then torque front bolts to 100-120 ft. lbs. torque, and rear bolts to 65-75 ft. lbs. torque.
8. Torque all remaining rear suspension bolts to revised torque specifications (See Figure 1) and remove support jack from beneath rear axle.
9. Install wheel and tire assemblies and lower car to floor.

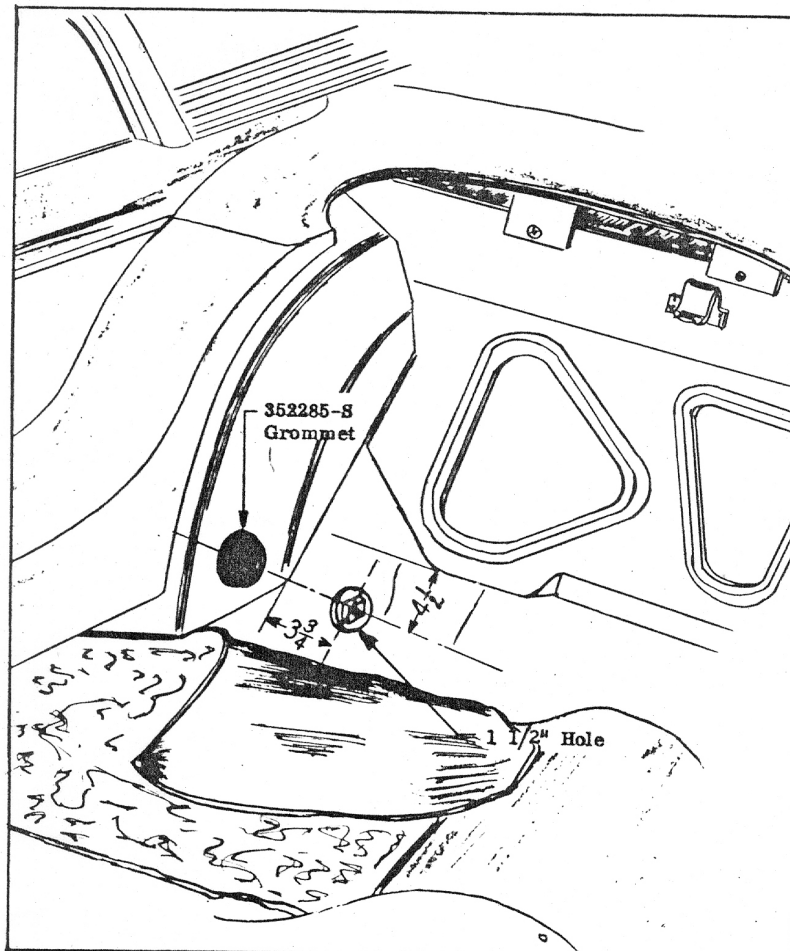
Figure 2 - Fix for Stripped Threads or Loose Nut

**CORRECTION (B) STRIPPED THREADS—
UPPER SUSPENSION ARM FRONT MOUNTING
NUT**

**CORRECTION (C) UPPER SUSPENSION ARM
FRONT NUT LOOSE**

1. Remove the rear seat cushion and rear seat back assemblies, then locate and drill a 1½" diameter hole (See Figure 2).
2. Raise rear of car and remove rear tire and wheel assemblies then remove the bolt from the forward upper arm bushing.

3. Drill through the existing nut with a ¼" drill then split the nut with a chisel and remove from underbody rail. (Remove pieces of nut from spring pocket area with a magnet.)

4. Re-assemble the front bushing and bolt assembly (discard the star type lock washer and substitute a spring type ¾" lock washer).
5. Grind or file weld flash from inboard side of underbody rail then place a ⅝"-18 nut in the access hole.

6. Tighten the bolt to secure the nut, then arc weld the nut to the frame side rail.
7. Torque bolt to 100-120 ft. lbs.
8. Install grommet part number 352285-S in the drilled access hole then reinstall the seat back and seat cushion assemblies.

1. Repeat operation number 1 of Correction (B).
2. Raise the car and remove rear tire and wheel assemblies, then tighten the bolt in the forward upper arm bushing to 100-120 ft. lbs.
3. Repeat operations 6, 7, 8, and 9 of Correction (B).
The suggested time required to perform Correction (C) is 0.2 Hours for one side, 0.3 Hours for both sides.
