# BODY

## 7 SEAT CHUCKING (1958 Thunderbird)

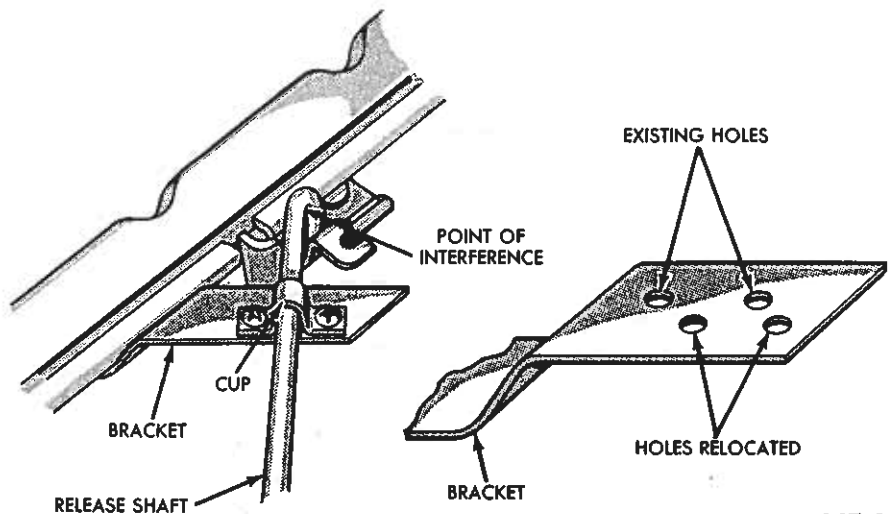
Fig. 1 - Seat Chucking Correction (Item 7)

Seat chucking on the 1958 Thunderbird is caused primarily by:

1. Loose seat track attaching bolts.
2. Improper engagement of the locking pawl at the seat track.

Some early production 1958 Thunderbirds have a mislocated clip securing the lock release shaft (Fig. 1). This causes the shaft to bind against the seat track. If bending the tab does not correct the bind, it will be necessary to relocate the clip on the tab (Fig. 1).

These conditions can be corrected by removing the seat assembly and tightening all of the attaching bolts securely, particularly the seat track to seat cushion frame bolts.

Then, operate the release lever and observe if the locking pawl engages completely into the slots on the seat track. If complete engagement is not obtained, it will be necessary to align the release lever shaft by bending the tab nearest the seat track. This tab should be bent slightly up or down until free movement of the release lever shaft is obtained and the pawl completely engages the slots in the seat track.

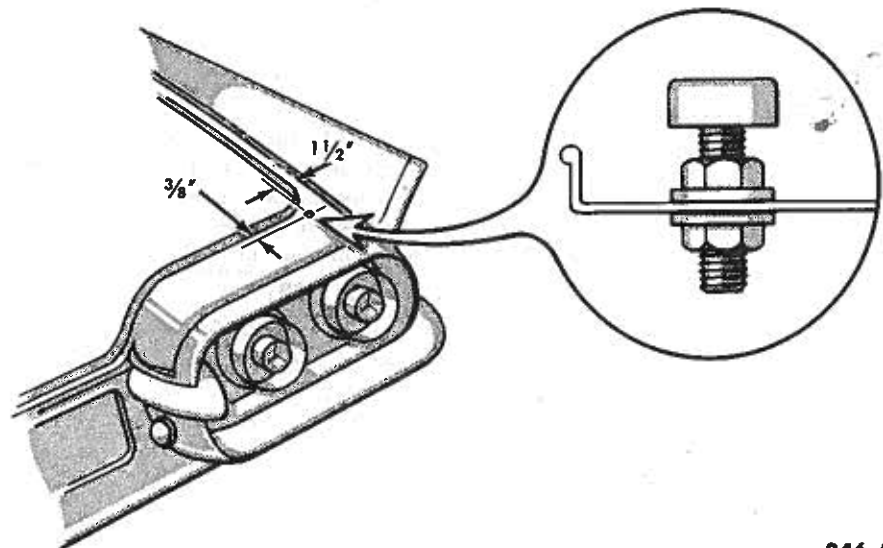
Fig. 2 - Deck Lid Bumper Installation (Item 10)

Excessive flexing at the rear corners of the 1958 Thunderbird deck lid can be corrected by adding a rubber bumper (B5A-16769-A) at each rear corner as follows:

1. Remove the trim panels from the rear surface of the luggage compartment. Locate and drill a 3/8" diameter hole at each rear corner as shown in Fig. 2.

2. Install an adjustable rubber bumper (B5A-16769-A) with a flat-washer on both sides of the sheet metal and secure each of the bumpers in place with the two hex-head nuts (Fig. 2).

3. Adjust the height of the rubber bumpers to obtain a flush fit of the deck lid and the quarter panel surfaces.
