SERVICE LETTER P-398

JULY 25, 1958

REAR SUSPENSION NOISE (1958 Thunderbird)

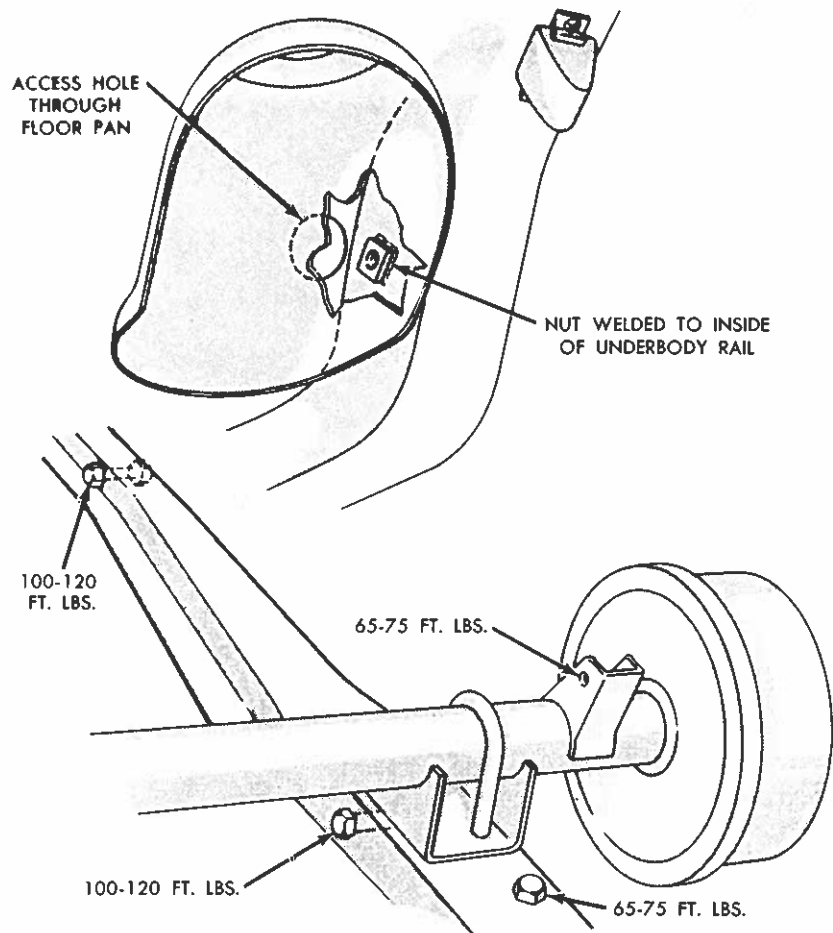
Fig. 1 - Rear Suspension Noise Correction

On the 1958 Thunderbird, most of the rear suspension noises are caused by the following:

A. Incorrect torque of the rear suspension bolts and nuts.

B. Rear upper suspension arm looseness. This is caused by one or more of the following conditions:

1. Underbody rail distortion or collapse and excessive clearance between the front upper suspension arm mounting bolt and the underbody rail.

2. Stripped threads on the upper suspension arm front mounting nut.

3. Upper suspension arm front nut loose.

In some cases, the spacer, installed in the frame at the rear axle upper suspension arm front attaching bolt location, will collapse when the bolt is torqued to 100-120 ft. lbs. When the spacer collapses, the outer frame side rail may also collapse slightly and allow the arms to loosen.

When rear suspension noise problems are encountered, the rear suspension members should be torqued to the specifications shown in Fig. 1. In those cases where the torquing operation does not eliminate the noise, and the noise is attributed to the upper suspension arm, the arm and attaching parts should be reworked as follows for the conditions which are found to exist.
