Service Letter

58-G-18

1958 Thunderbird miscellaneous items

REAR SUSPENSION NOISE

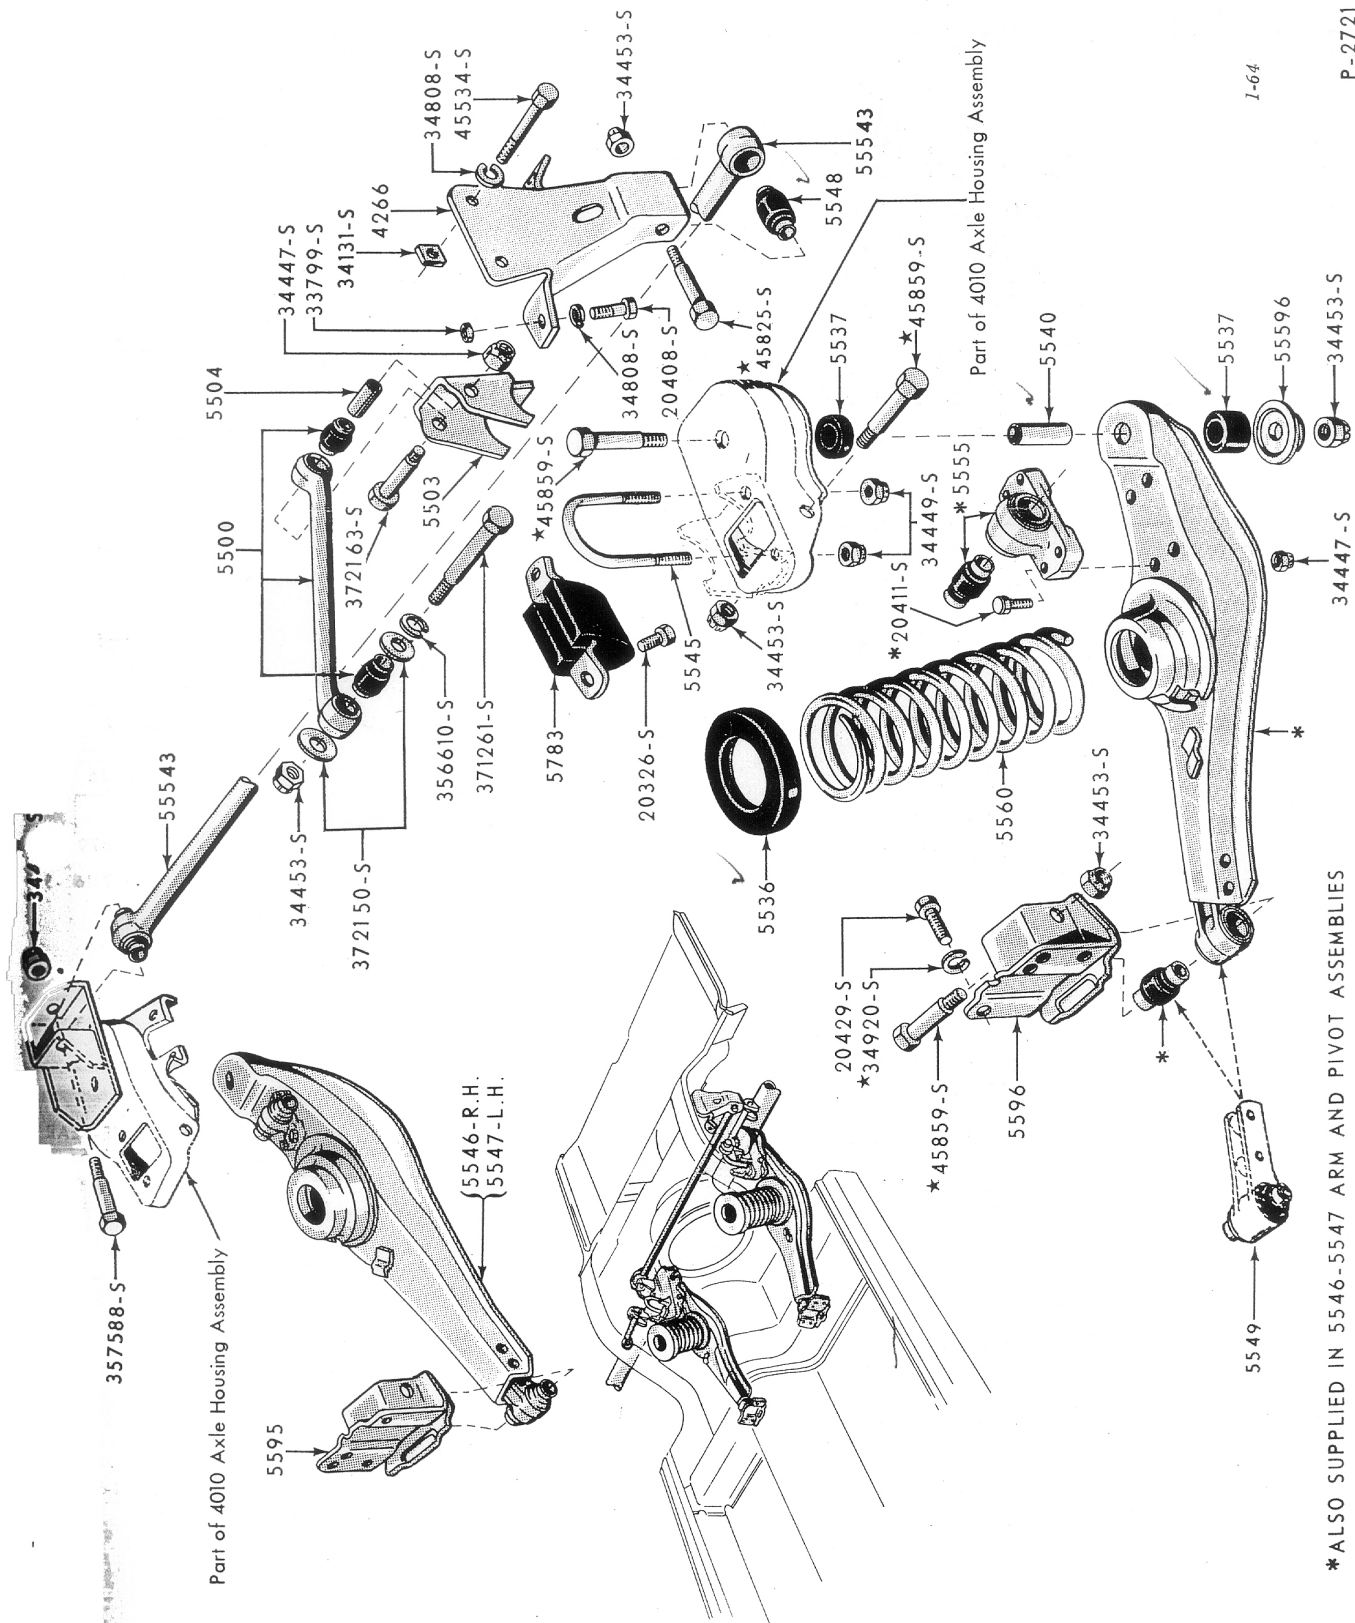
Figure 2 - Fix for Stripped Threads or Loose Nut

1. Incorrect torque of the rear suspension bolts and nuts.
2. Upper suspension arm looseness. (Upper suspension arm looseness has been found to be caused by one or more of the following conditions):
 - A. Excessive clearance between front bolt and underbody outside rail.
 - B. Stripped threads—upper suspension arm front mounting nut.
 - C. Nut loose on underbody rail.

1. Remove the rear seat cushion and rear seat back assemblies, then locate and drill a 1½" diameter hole (See Figure 2).
2. Raise rear of car and remove rear tire and wheel assemblies then remove the bolt from the forward upper arm bushing.
